**mcHF Hardware modifications as of September 28, 2015 as compiled
by KA7OEI for the Version 0.3/4 UI and Version 0.4 RF boards**

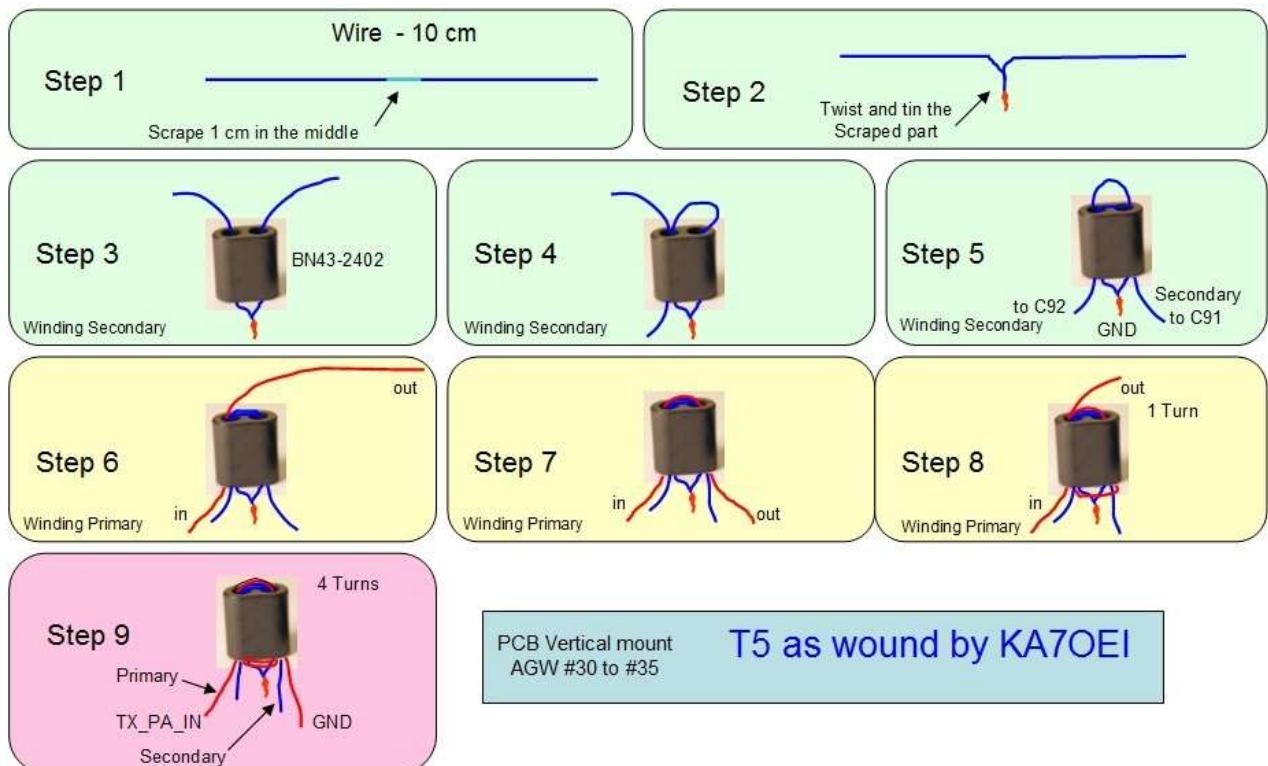
Step-by-step winding guide for constructing "T5"

The original part number for transformer T5 on the RF board called for a 1:4(CT) transformer, but a circuit analysis will indicate that this is inappropriate for the impedance of Q4/Q5, the RF Driver transistors. The current BOM calls for a 1:1(CT) transformer – a “less bad” match, but still not ideal in that there is a mismatch causing ripple/loss in the bandpass filters but it is less severe than with the original 1:4 impedance.

A better transformer would be a 4:1(CT) transformer. Unfortunately, one cannot simply turn the original transformer “backwards” since it lacks a centertap on the necessary side in order to properly drive Q4/Q5. Fortunately, it is easy to wind a custom transformer using a BN43-2402 core – the very same core used for RFC8 – and some small-diameter wire.

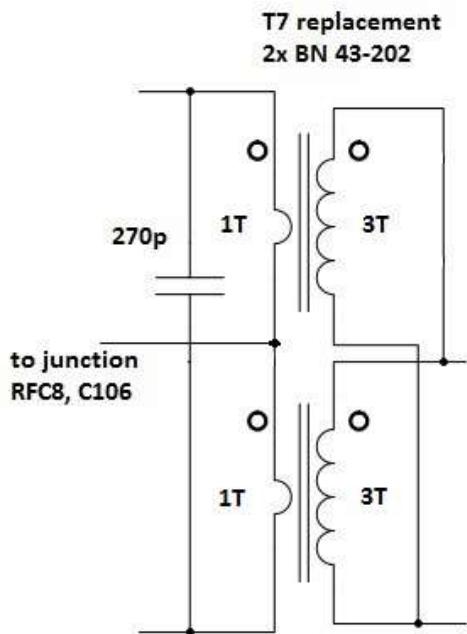
Wiring diagram of T7

- Primary/Secondary coupling not as tight as it should be
- Excessive leakage inductance
- Transformation ratio not optimal for maximum power output at good efficiency
- Reactance associated with the transformer and other final circuitry is not compensated

As it turns out there are several possible solutions to this problem, all of them using the BN43-202 ferrite core and the solution depicted – one of several proposed – uses **two** of these cores.

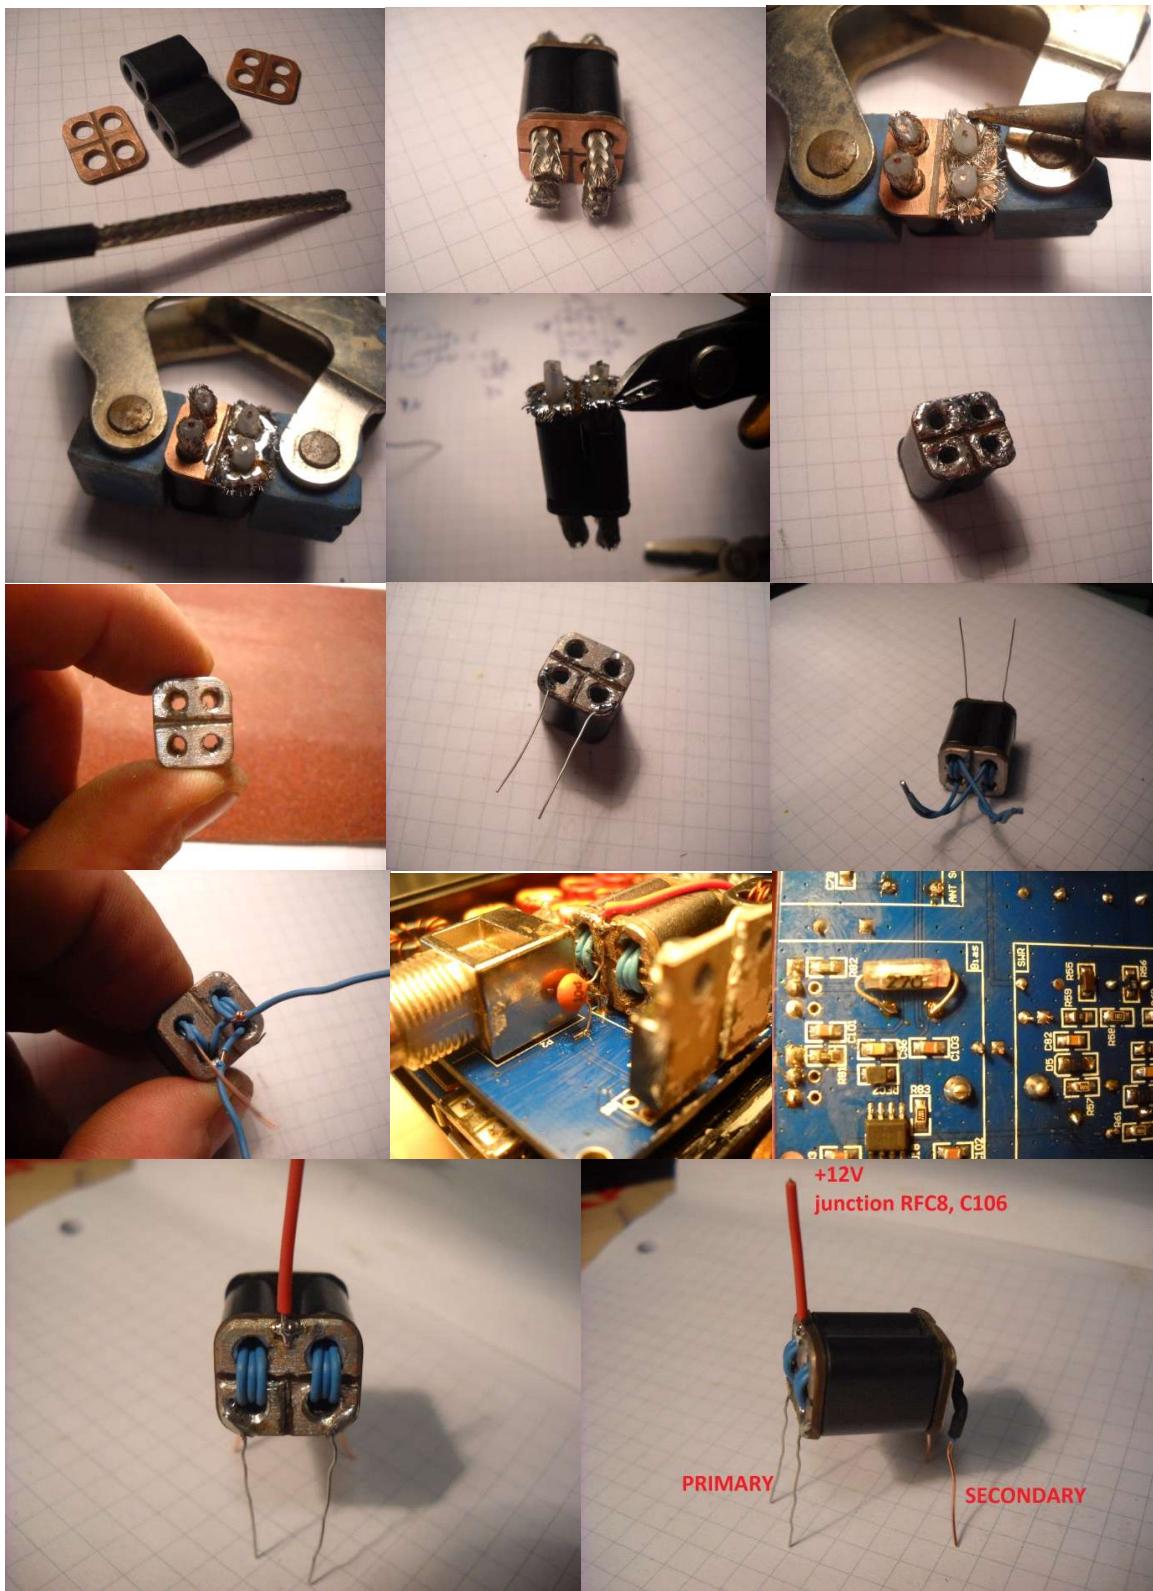
*Details of the constructing, winding and mounting a version of T7, the PA output transformer.
Thanks to Marko, S54AM for these pictures.*

It is recommended that the secondary be wound with “Teflon” (PTFE) covered wire if it can be obtained since it is capable of handling high temperatures and its low coefficient of friction makes it easier to wind the transformer.

If one looks closely at the above pictures it can also be seen that on the “center-tapped” side of the primary (the left-hand photograph) a piece of copper-clad printed circuit board is used to connect the primary windings (the coax braid) inside each core together. While this makes for a very neat construction, it is not absolutely necessary, but if flat, copper material – such as PCB material or copper sheeting/flashing – is not used it is recommended that multiple strands of bare, copper wire be used to bond them together.

Finally, although not shown on the schematic – but visible in one of the photographs – it is recommended that a 0.1uF capacitor be connected between ground and where the V+ (red wire in the photograph) is connected on the two cores for optimal RF bypassing.

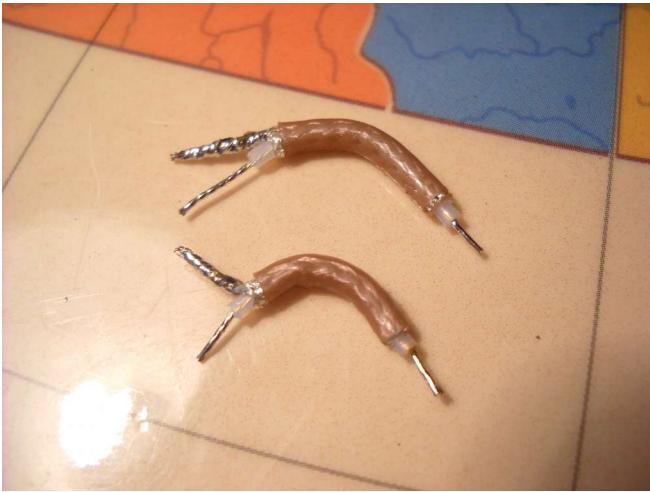
Preparation of the two small pieces of coaxial cable for the Faraday-shielded "primary" windings.

The first thing to do is to prepare two, short pieces of coaxial cable as depicted in the left-hand picture, below. Note that on each, the shield is cut off on only one end: The Faraday Shield works by blocking the “E” field radiated from the conductor, but not the “H” (magnetic) field – and it is the “E” field that can cause problems with anomalous, high VSWR readings on the higher bands, even if one is using a known-good dummy load!

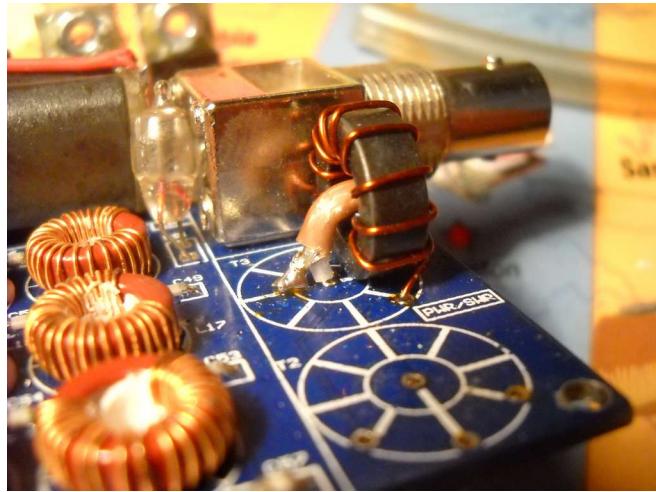
Connection and mounting of the transformer with the shielded primary.

If you use a polyethylene-based coaxial cable such as RG-174 care must be taken to avoid melting the dielectric when soldering the coax into place. A pair of needlenose pliers or tweezers may be used as a heat sink to minimize the amount of heat that is transferred to the plastic while soldering to prevent melting.

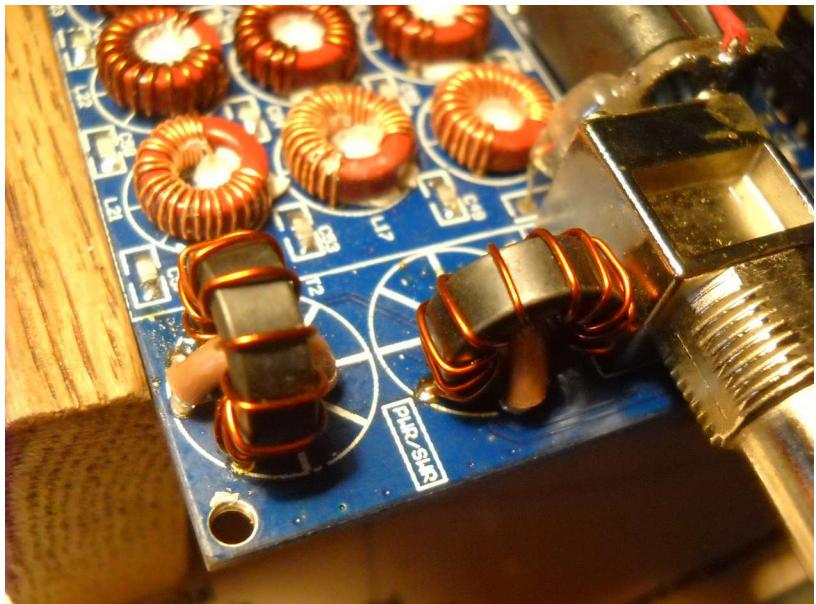
T2 and T3 installed with Faraday shield coaxial primary winding.

If you are retrofitting an existing T2/T3 installation you will want to clean the holes in the circuit board to be free of solder before installing T2/T3.

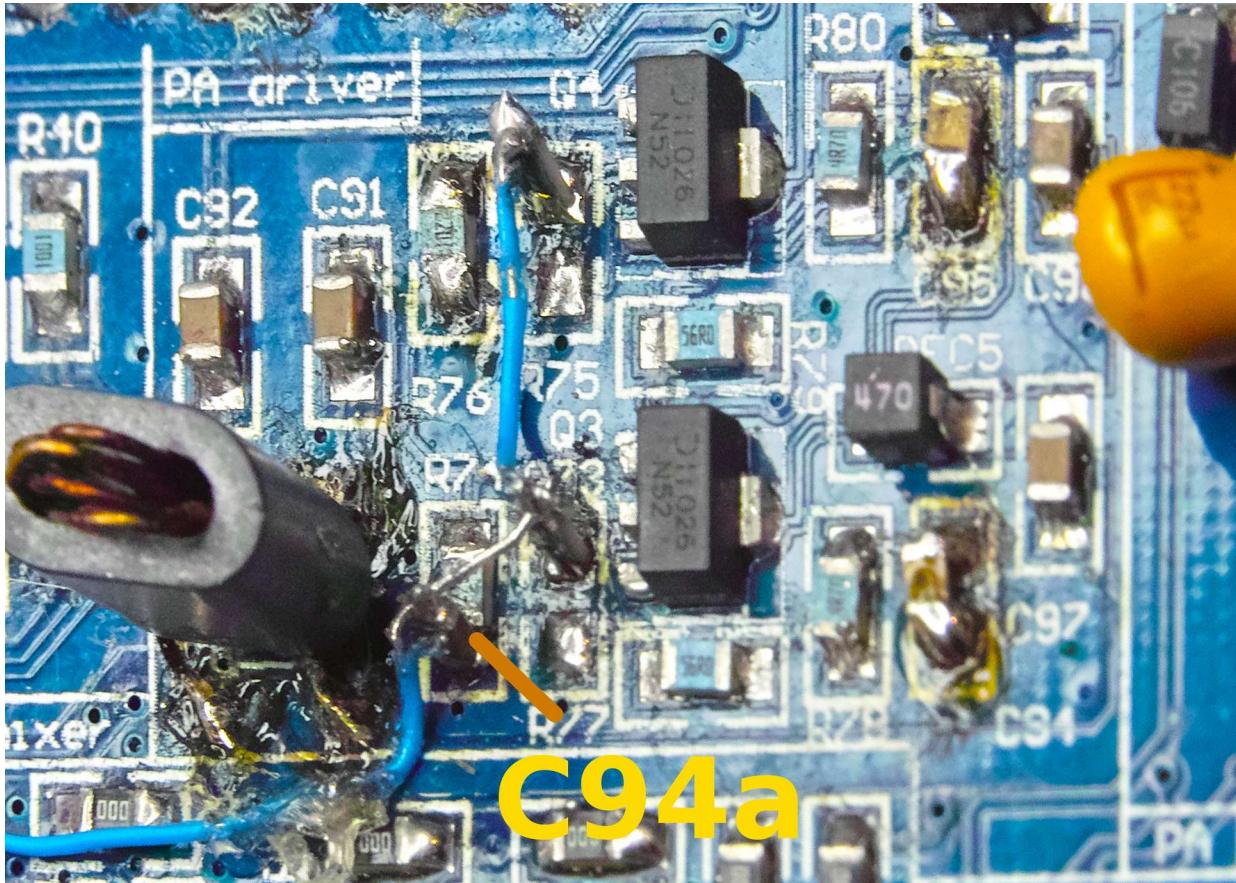
An example of the modifications to add PA bias switching.

Note that R74 and R75 are standing on-end and that C94a is also on-end, soldered to the ground side of R74. #30 AWG "wire wrap" wire connects the circuits together and to the junction of Q1a and R15, the source of the switch +5V supply and that this wire is tacked down with dabs of thermoset glue.

- Change R74, R76 to 2.2k
- Remove R73, R75
- Where R73, R75 would be, stand on end, in each location, a 2.2k resistor, the bottom end connecting to the base of transistors Q3, Q4.
- Solder, standing on end, 100nF capacitor(s) to the ground end of R74 and/or R76.
- Connect the "top" of these components (the two resistors and the capacitor(s)) together.
- Connect the tops of these components to the junction of R15 and Q1a (at R15) using a piece of very thin, insulated wire: I used #30 AWG wire-wrap wire, tacked down in several places with small dots of thermoset ("hot-melt") glue.

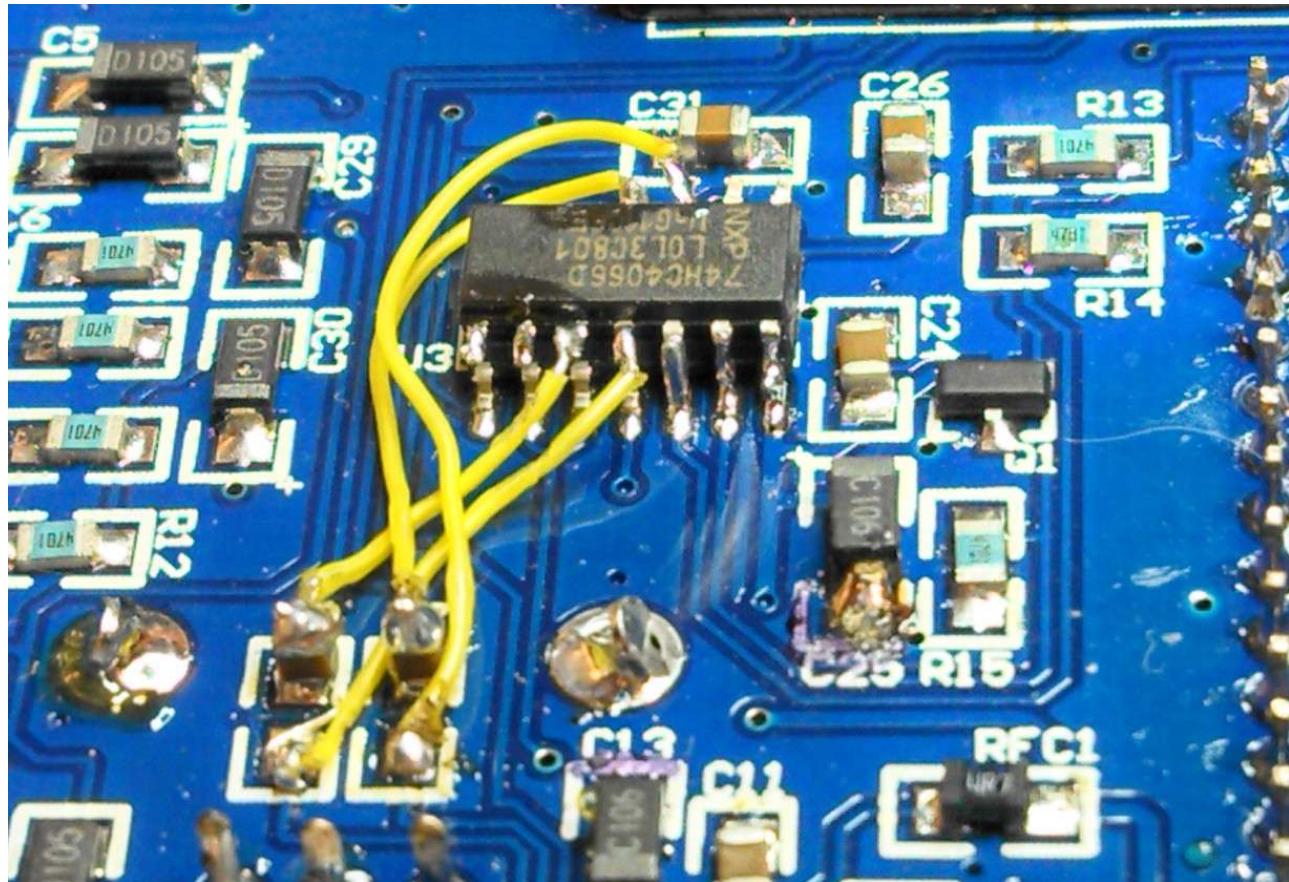
This fixes a source of distortion/oscillation in the receiver, particularly at high volume levels and on high bands: **This is a very important modification that all users of this transceiver using UI board version <= 0.3 should perform.**

The "U3a" modification, piggypacking another 74HC4066 atop U3 to prevent feedback into the receiver.

This modification prevents "breakthrough" of the TX QSD mixer (U17) caused by the fact that the Codec's DA is shared both for RX audio and TX modulation. Because the audio drivers for the TX modulator (U20-U23) are powered from 8 volts it is possible for high RX level audio to violate logic levels at U17, turning it "on" on voltage peaks: The result of this is highly-distorted, on-frequency noise/feedback.

Take a 74HC4066 chip, of the same type and package as U3 and piggyback it atop U3 (on the UI board) and use its power supply and control signals. This chip will now be able to turn on/off the TX I

- On the new 74HC4066, U3a, bend pins 5, 6, 7, 12, 13 and 14 straight down using a VERY FINE pair of needle nose pliers or tweezers. Bending these leads down will cause them to be just long enough to allow them to be overlaid atop U3 and connected to it.

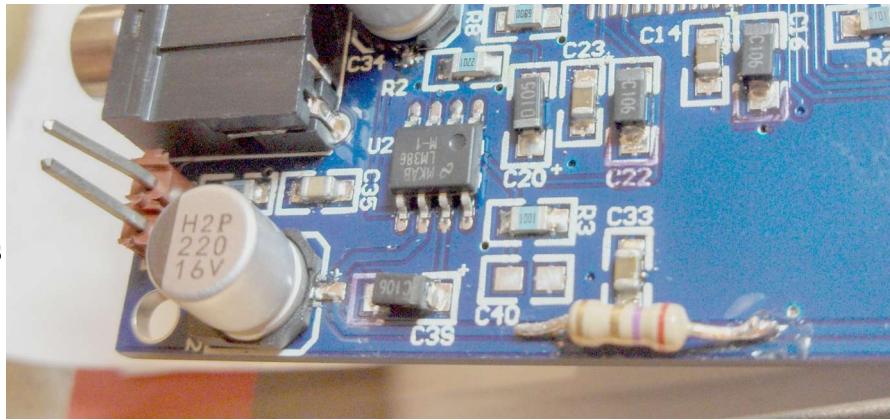
This modification prevents audio from appearing on the 8 volt line which, in turn, causes audio to appear on the ground busses and other power supplies in the radio which can cause feedback, particularly at high volume levels with wider audio filters.

The 4.7 ohm resistor added to the UI_8V line feeding U2, the audio amplifier.

I'd originally suggested a 2.7 ohm resistor, but I later found 4.7 ohms to be better, as Chris pointed out.

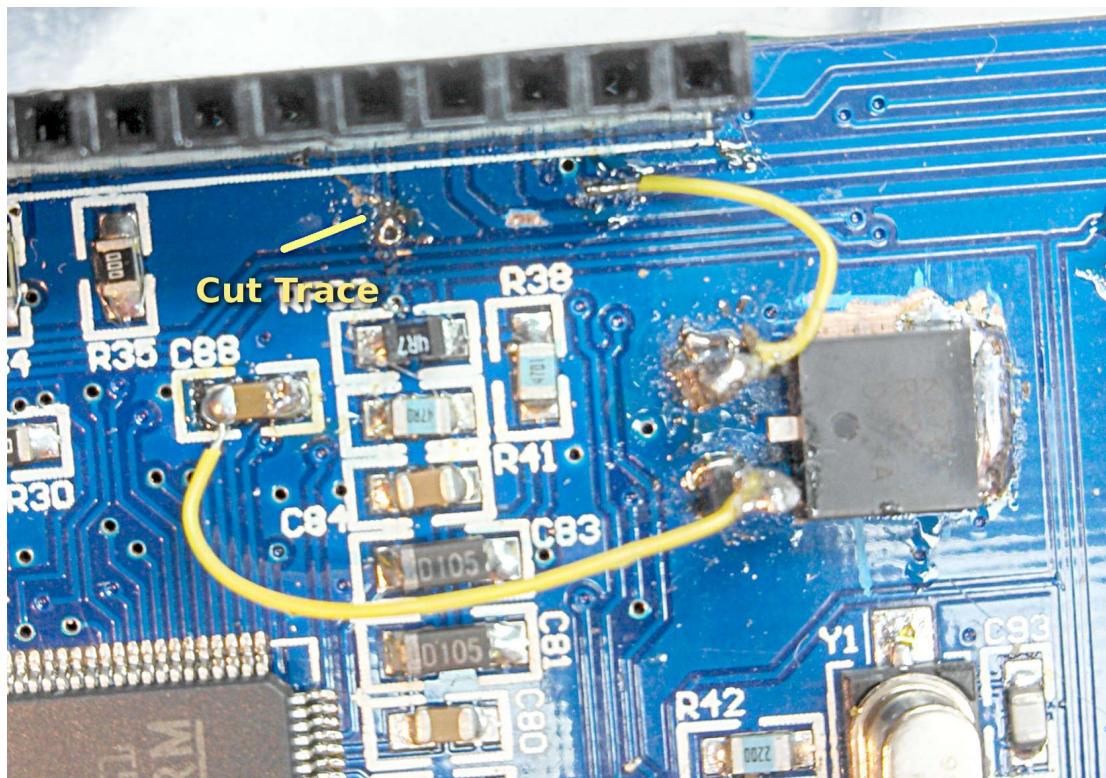
The added 3.3 volt regulator to deliver an isolated power supply to U4a, the MCU. This reduces a noise source that can get into low-level RF and audio stages. The trace is cut just above the via.

This picture was taken before the addition of the 4.7 ohm resistors and additional capacitors described below and is included for clarity.

This leads to the recommended installation of another 3.3 volt regulator on the UI board for the MCU: This mod is actually easier than the "U3a" mod and uses the same type of parts as those that you'd already have gotten (e.g. another 3.3 volt regulator and two more 10uF capacitors.) This reduces one source of low-level noise – much of it in the form of a 1.5 kHz “whine” – getting into the receiver due to the MCU's modulation of current on the 3.3 volt line shared with low-level audio circuitry. Taken together, these two modifications can improve the receiver sensitivity by 2-3 S-units, depending on band.

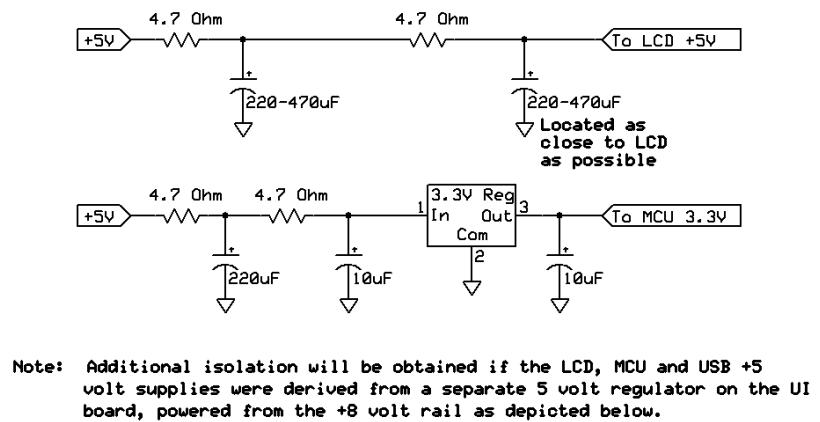
The diagram shows the filtering in schematic form. There is a voltage drop associated with each resistor, but each is well within the range of the associated device and load.

- The LCD has an internal 3.3 volt regulator that has a (worst-case) dropout voltage of 600mV – and less than 1 volt is dropped across the two 4.7 ohm resistors.
- The MCU regulator drops less than 250 mV per 4.7 ohm resistor, leaving well over a volt of headroom for the low-dropout regulator.

Diagram depicting the MCU's own, isolated 3.3 volt power supply. This also shows additional isolation of the LCD power supply as well as the suggested, separate 5 volt power supply for the UI board - see text.

For LCD filtering, place the noted capacitor as close to the LCD's pins as possible – preferably *at* the LCD itself! The 4.7 ohm resistors and the other capacitor may be placed farther away, but the second capacitor should be placed as close to the LCD's ground as well.

In the future, it is expected that USB devices may be plugged into J10 and/or J11, powered from the mcHF. Because these, too, use the +5 volt supply that is known to be very sensitive to noise, it would be prudent to isolate this supply as well as noted in the diagram, above.

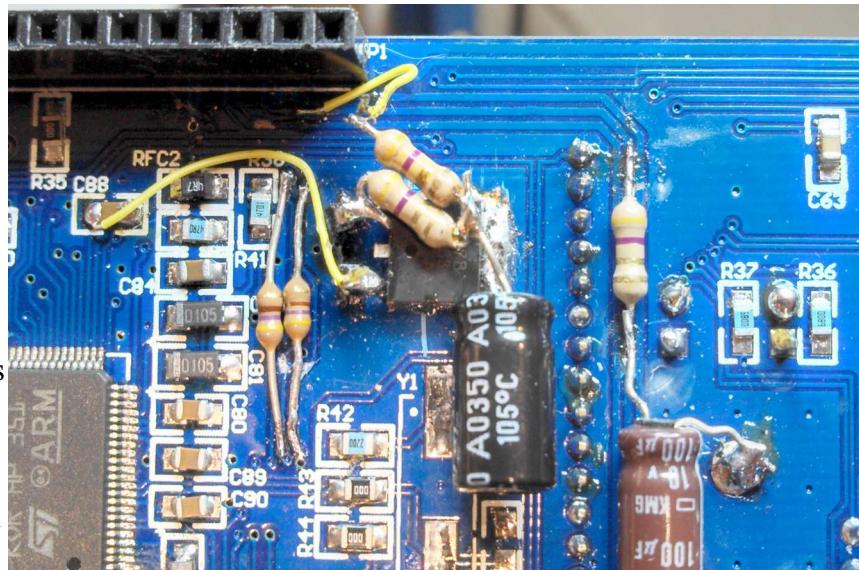
With the increase in sensitivity due to the reduced receiver background noise there may be the additional tendency for audio feedback to occur at high volume levels, particularly with no antenna connected ***when using a speaker***.

The modifications showing the 3.3 volt regulator (center) and increasing the capacitance of C32 to filtering and the additional filtering of the 5 volt LCD line (right). 1000uF can reduce this effect, as can the use of headphones or an external audio amplifier.

The resistor to filter the "tick" (see next section) are also visible.

If this describes what is happening to you, this fix is also quite simple: Increase the capacitance at C32. It has been found that adding another 1000 uF of capacitance across C32 seems to prevent audio feedback, having done all of the other modifications.

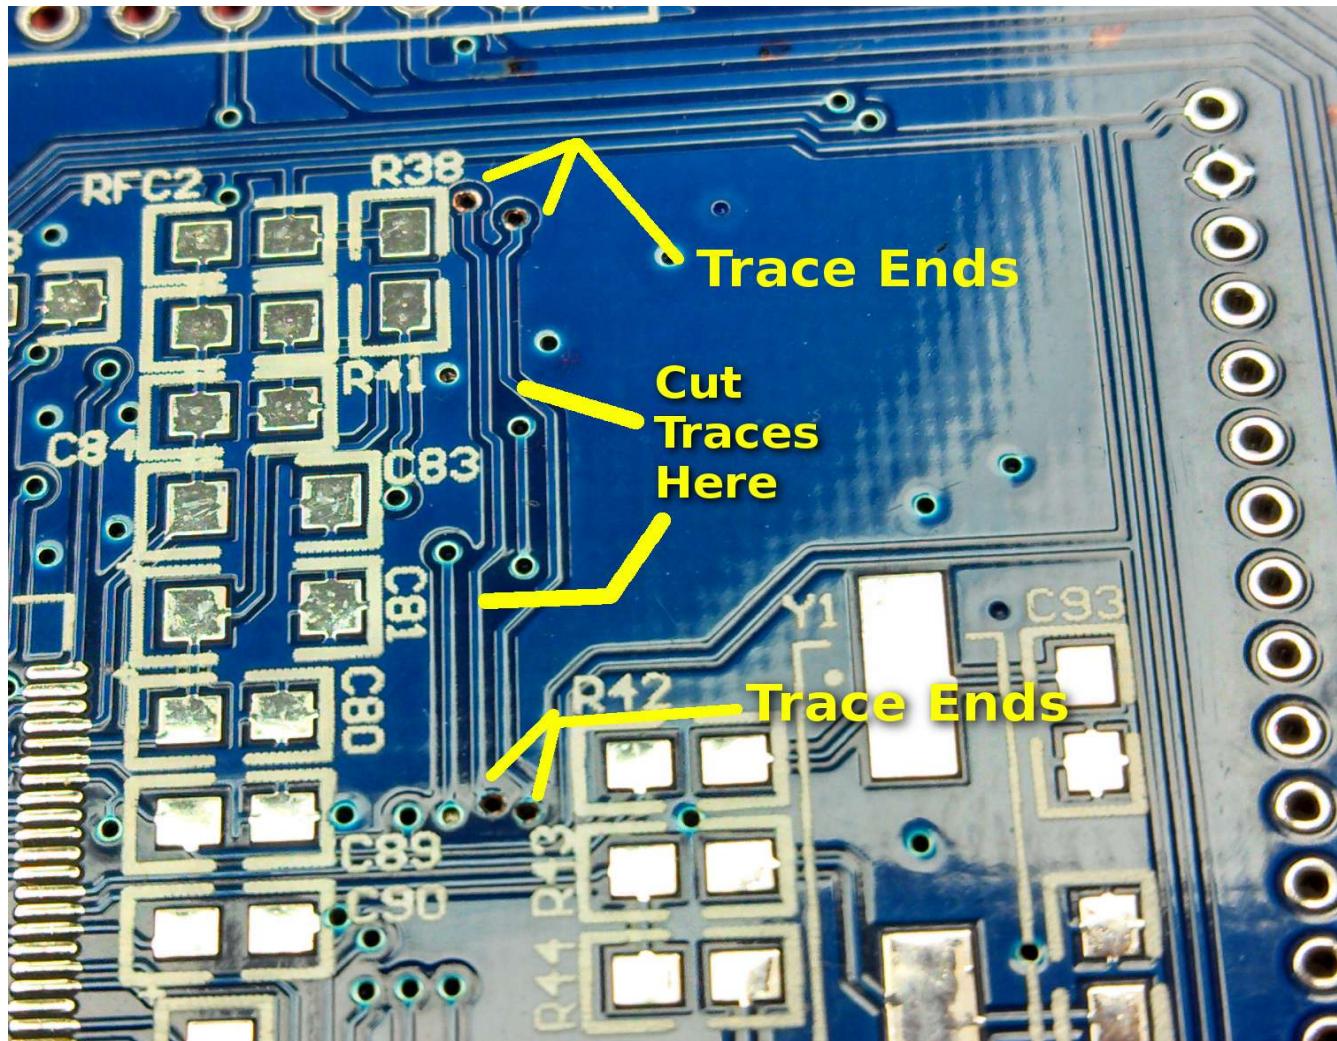
If the above modifications are made, with no antenna connected – or even with an antenna connected when listening on higher bands (especially 20 meters and above) a fairly strong “tick” may be heard every second. This is due to the polling of the onboard temperature sensor and the fact that the “fall” time of the on the I2C line from the MCU is extremely fast and rich with harmonic energy. This problem can be easily “fixed” with the addition of resistors on the UI board in series with the SCL and SDA lines which effectively reduce the slew rate of these lines, quashing the RF energy.

This picture shows the location of the traces and where the cuts should be made. This is found to the right and above U4a, the MCU. A picture of a “bare” board is used for clarity.

A reasonable value of resistor to install is 470 ohms and the installed components may be seen in the picture.

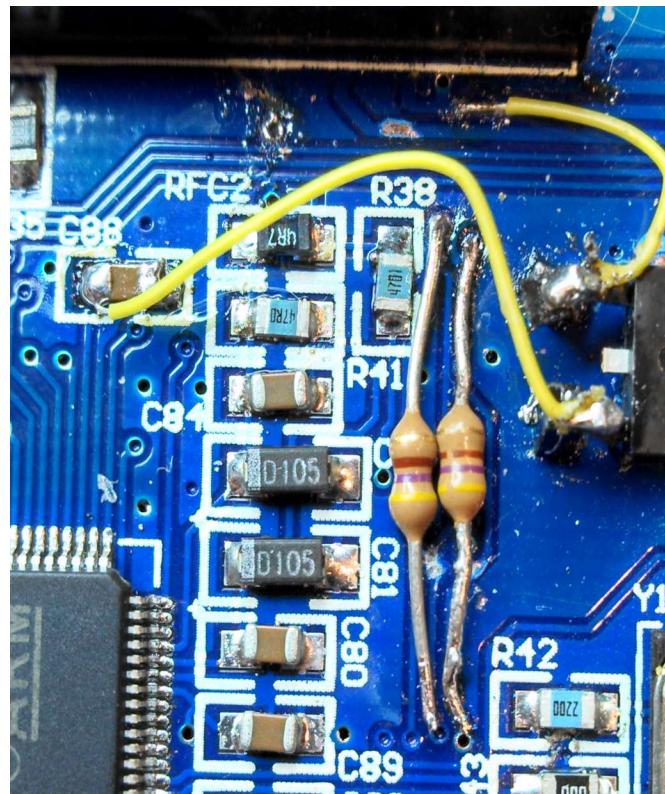
The added 470 ohm resistors in series with the SCL and SDA lines. Note that this picture also shows the added 3.3 volt MCU regulator mentioned above. 1/8 watt, leaded resistors are used, but surface mount resistors could be used, if

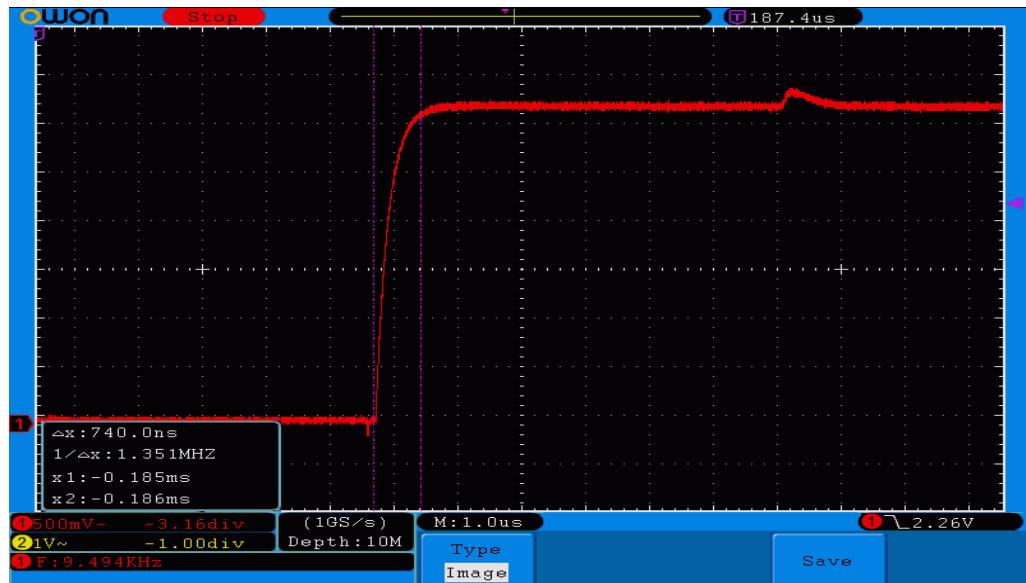
To verify the integrity of the I2C data stream – which is shared with the Si570 frequency synthesizer – I monitored the data stream with a digital storage oscilloscope and measured the worst-case slew rate – which was actually the risetime - the result being noted below.

Of the rise and fall times on the I2C, the slowest slew rate was the rise time shown in this digital oscilloscope capture, which is well within the acceptable time for the clocking rate!
